**Phase I ESA - Mountain Iron Dump,  
in Mountain Iron,  
St. Louis County, Minnesota**

Phase I Environmental Site Assessment -  
Mountain Iron Dump in Mountain Iron,  
St. Louis County, Minnesota

97511-D

November 15, 2000

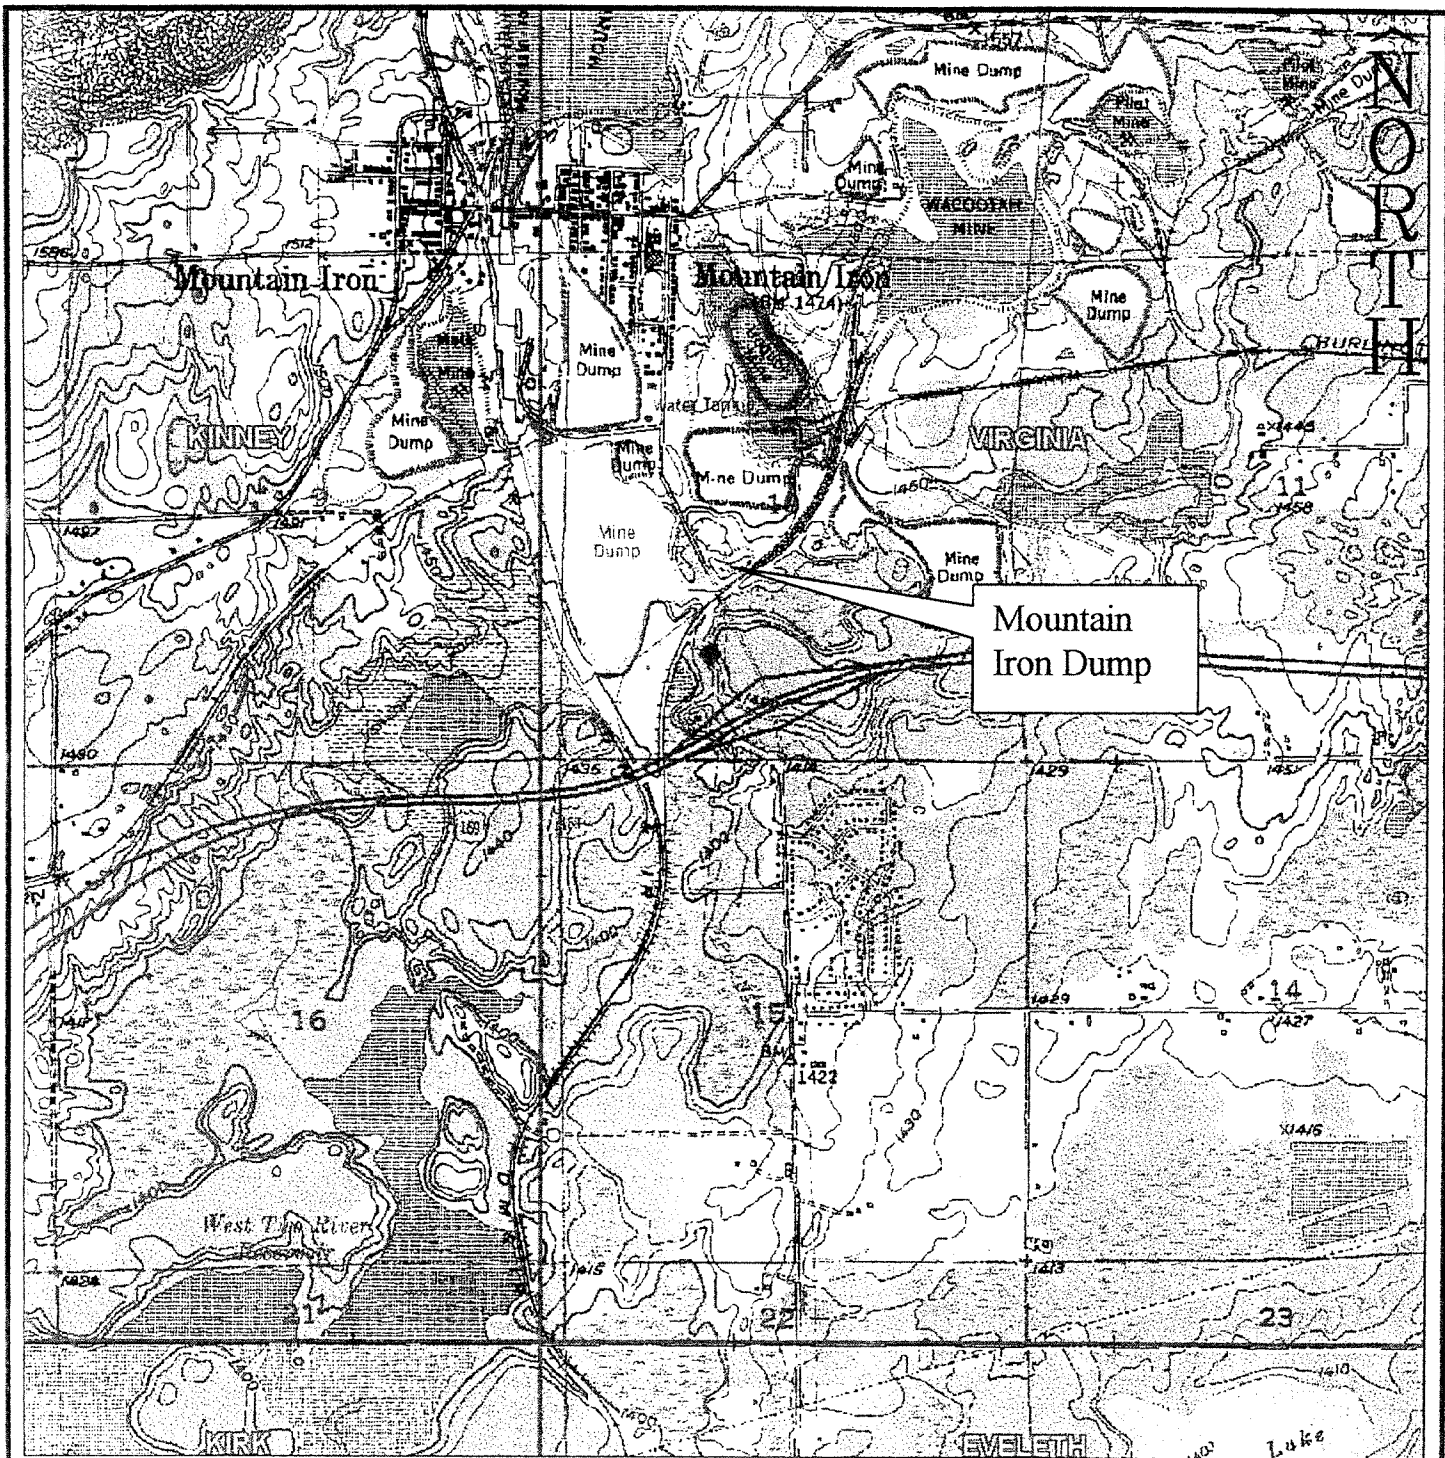
DRAWN BY	JPR
CHECKED BY	GJR
APPROVED BY	RLD
CADFILE	SCALE 1" = 2000'
STS PROJ. 97511-D	FIGURE NO. 1

**SITE LOCATION DIAGRAM**  
**Phase I Environmental Site Assessment**  
**Mountain Iron Dump**  
**Mountain Iron, Minnesota**

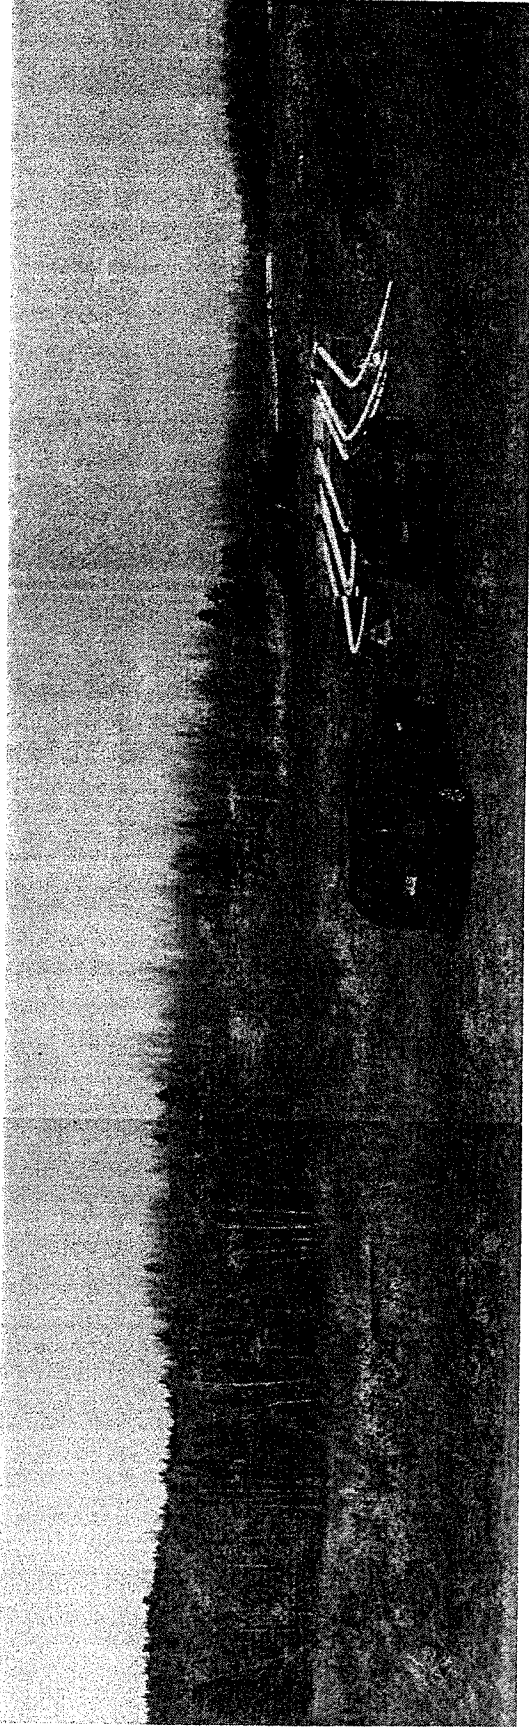
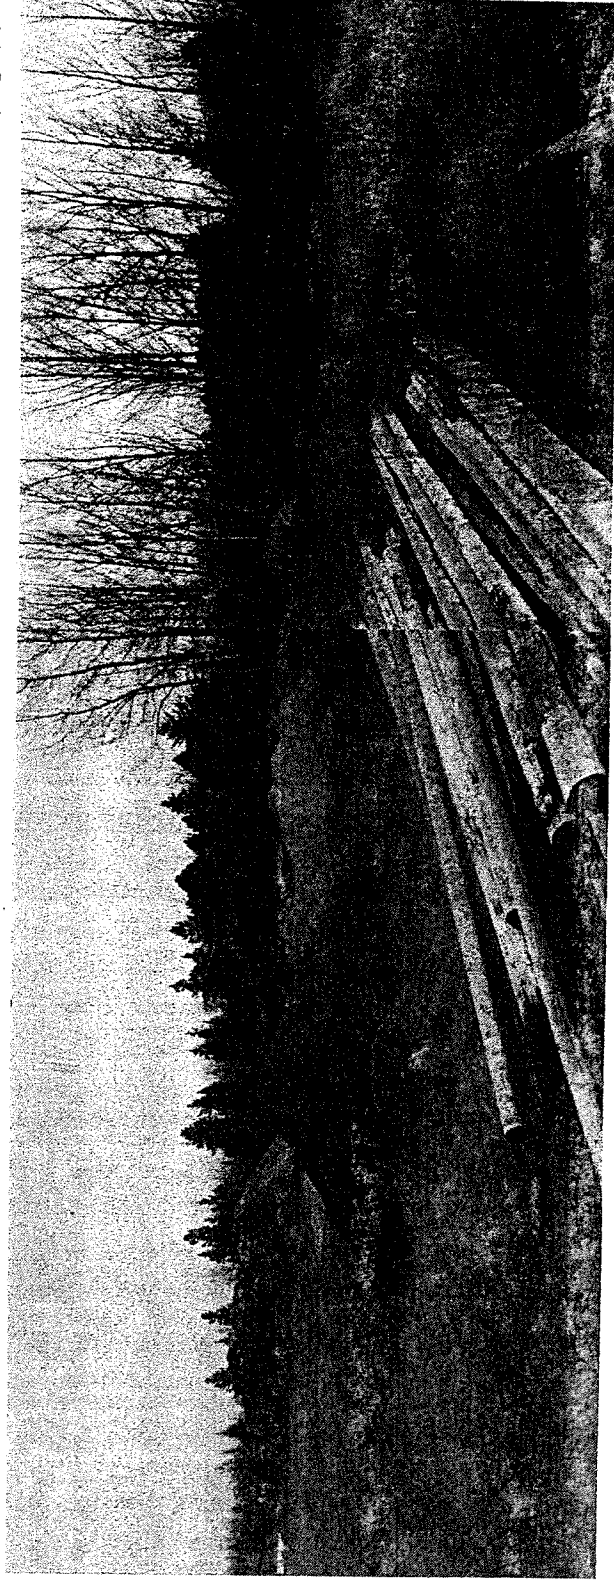
Photographs 1 and 2 - The Mountain Iron Dump is currently used as a staging area for utilities materials by the City of Mountain Iron Public Works Department. (Panorama looking northeast (left upper photograph) to southeast (lower photograph).)

The Mountain Iron Dump is currently used as a staging area by the City of Mountain Iron Public Works Department, see Photographs 1 and 2 in Appendix E. Pipes, culverts, road aggregate materials and power poles were stored on the surface of the dump.

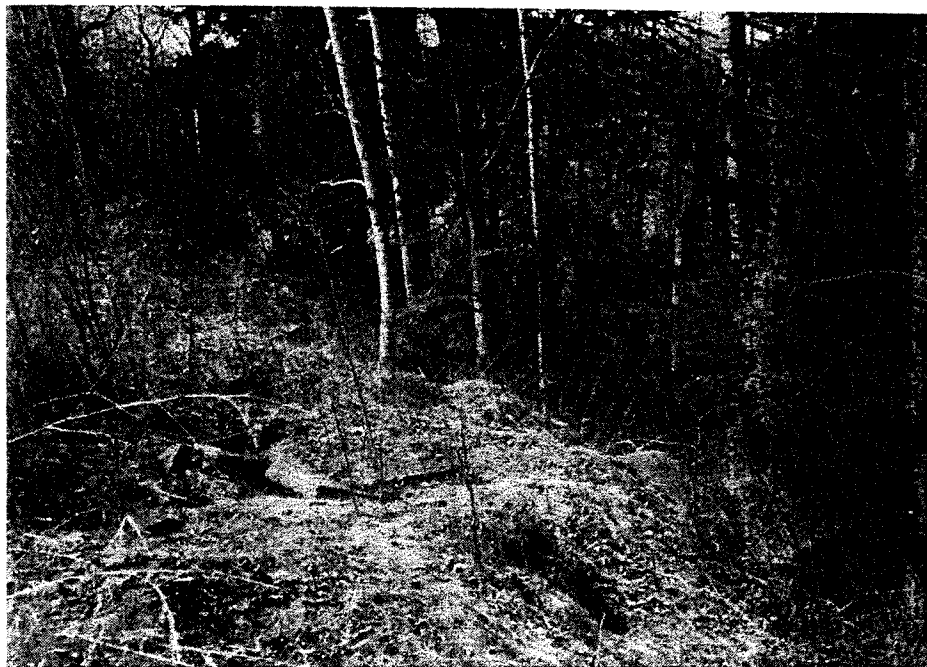
Photograph 3 - Few exposed wastes, such as broken concrete, were observed along the north face of the Mountain Iron Dump.

The dump surface, currently used as a staging area by the Mountain Iron Department of Public Works, is poorly vegetated. Dump side slopes are well vegetated. Few exposed wastes (chunks of concrete) were observed. A pond and associated marsh are adjacent to the north side of the dump.

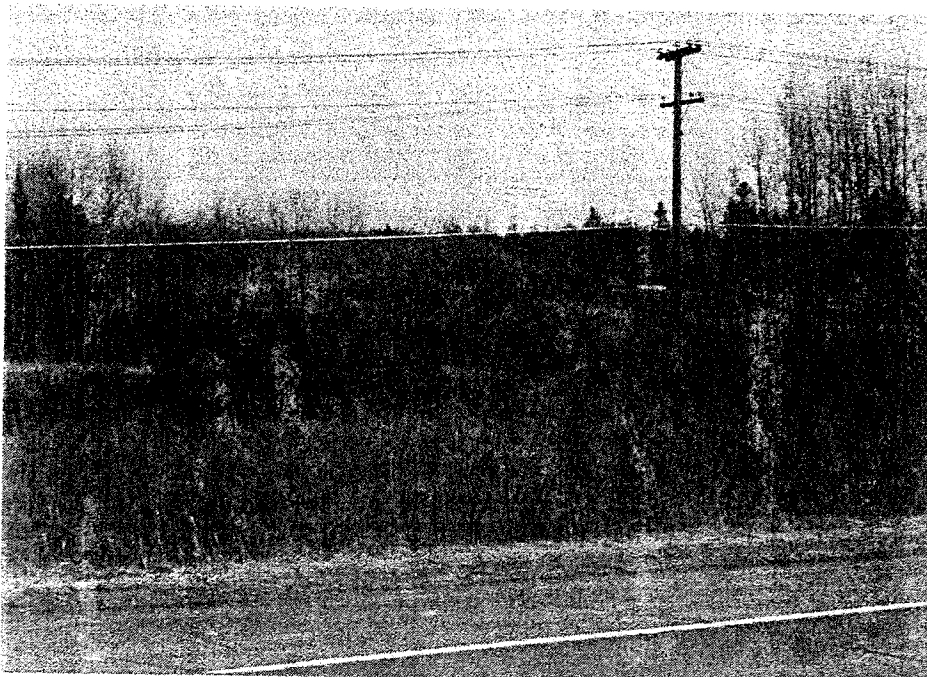
Photograph 4 - The north side of the Mountain Iron Dump (background of photograph taken looking southeast at the dump from County State Aid Road 102) borders a pond/marsh.

The Mountain Iron Dump is bordered on the north by a pond and marsh, on the south by a trail (former railroad track), on the east by woods, and on the west by an electrical substation and County State Aid Road 102.
